Willow Creek III
Tulsa, OK

Report #: 42921-0
Beginning: January 1, 2022
Expires: December 31, 2022

RESERVE STUDY
"Full"

December 3, 2021

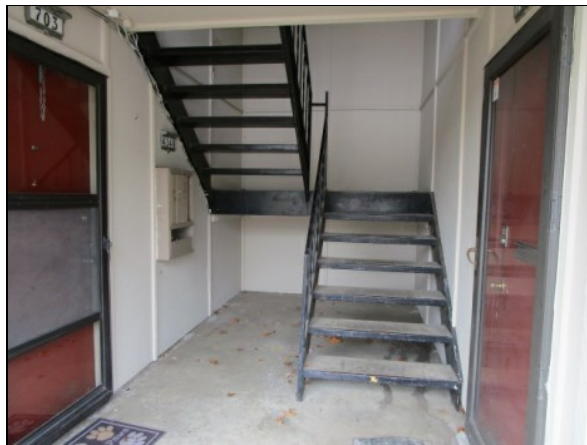
Comments: A funding allowance for the immediate decking repair work is included in the scope of the association's recent major projects loan. The staircases appear to be aging normally. To ensure stability and safety, major repairs should be made at periodic intervals. This component provides a funding allowance for this work. It is unlikely that the association will ever have to replace all of the staircases at one time.
